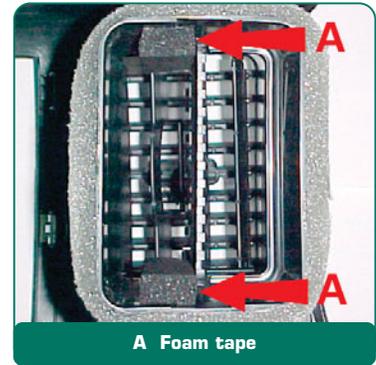
Some owners of a 2007-08 full-size utility or pickup may comment about a rattle/popping/snapping type noise in the left center IP air deflector when the blower is on. This condition may be due to the air flow door being loose and vibrating. The noise will be eliminated or reduced if the thumb wheel is slightly rotated to close off the air flow.

To correct this concern, remove the left center air outlet deflector. With the airflow door in the full open position, to allow air flow, install a piece of black foam tape (obtained locally) along the top and bottom of the deflector housing so it just touches the air flow door. The foam tape should be positioned on the side of the air flow door so it does not obstruct the door from closing. With the foam tape properly installed, the air flow door will slightly contact the foam tape when in the full open position, preventing the door from vibrating.

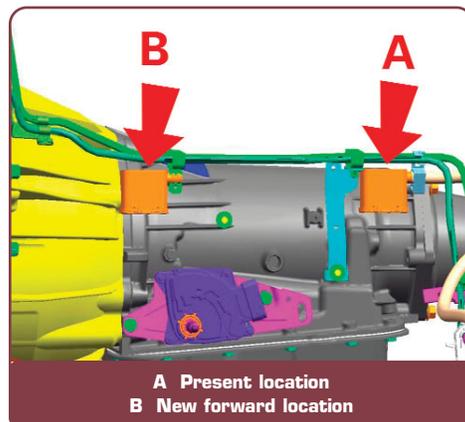
Some 1999-2008 full-size pickups may be operated in dusty or muddy environments, such as farming, mining or off-road type applications. An owner may comment about the illumination of the SES light, with a DTC P0446 (Restricted/Blocked EVAP Vent Path) being set.

If the prefilter intake is plugged with dust or mud, relocate the prefilter forward an additional 8 5/8 inches (220 mm) from its present location.
