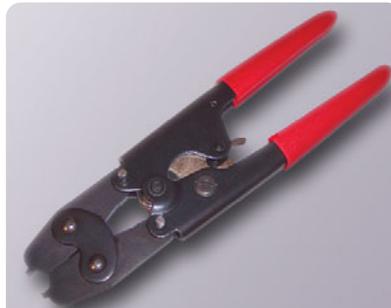
CH-48894 Pliers

This tool is required to properly service Oetiker low-profile drive axle boot clamps. The double-fulcrum design of CH-48894 accommodates one-handed operation and the working end is designed to properly interface the Oetiker low-profile clamps without damaging the clamps. Attempts to service the low-profile drive axle clamps without this tool may result in component damage and/or increased labor time.

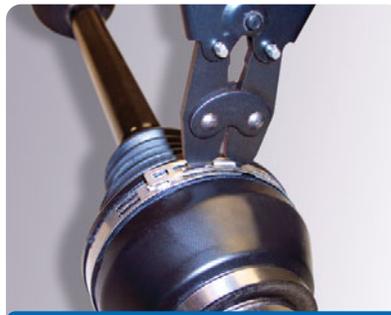
Crimping axle boot clamp

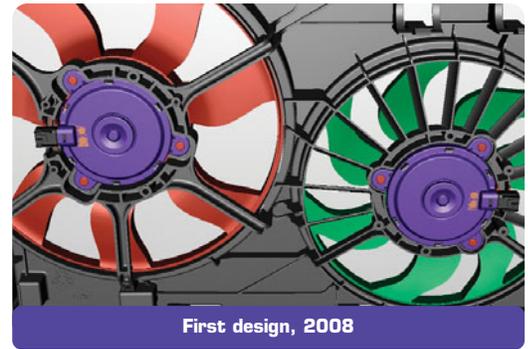
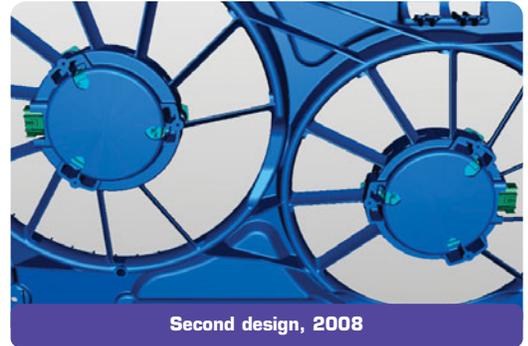
Engine Cooling Fan

2008 Equinox and Torrent vehicles built through the month of November 2007 will use the same twist-lock style fan blade design as the 2006 and 2007 model years. During November, a new supplier will begin providing new fan shroud assemblies for these vehicles. The fan shroud assembly components are not interchangeable between the two designs.

The second design 2008 fan blades are reusable, but the fan blade retainers must be replaced. These are the same fan blade retainers used for the 2005 model year.
